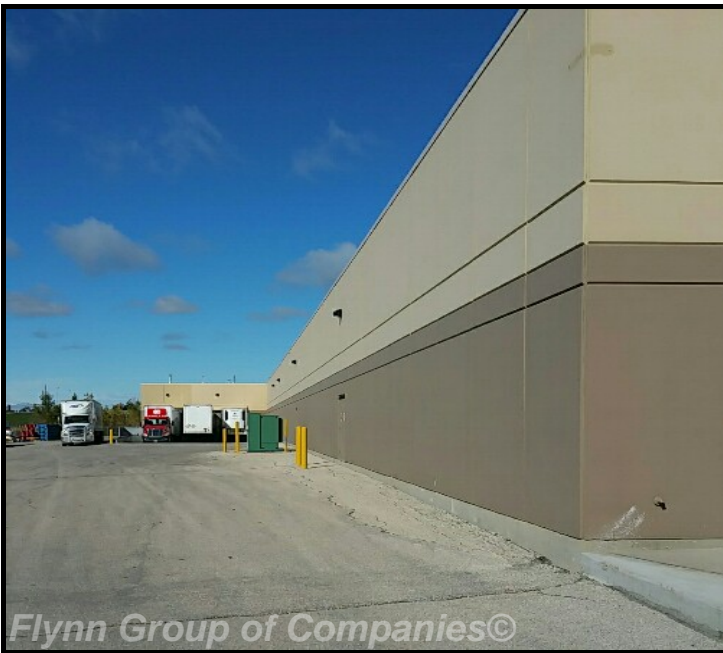
Overview: Exterior view of the east delivery docks.

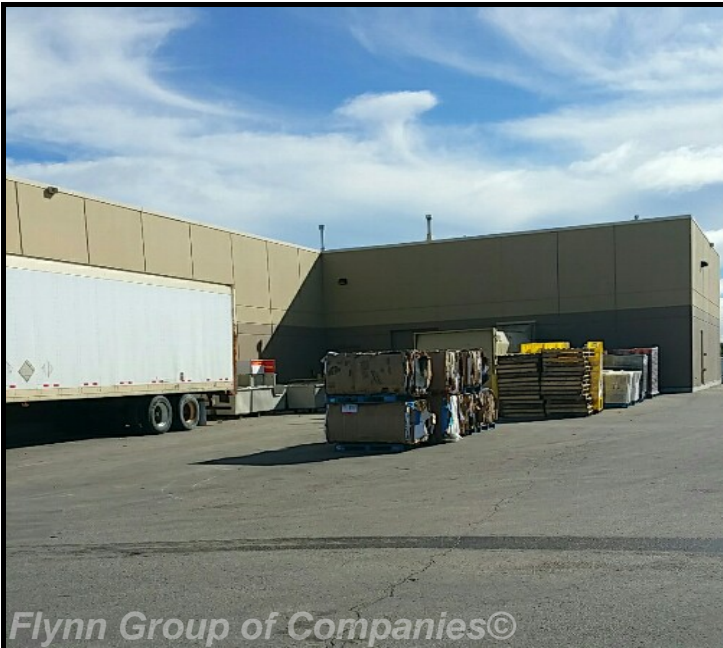
Overview: Exterior view of the west delivery docks.

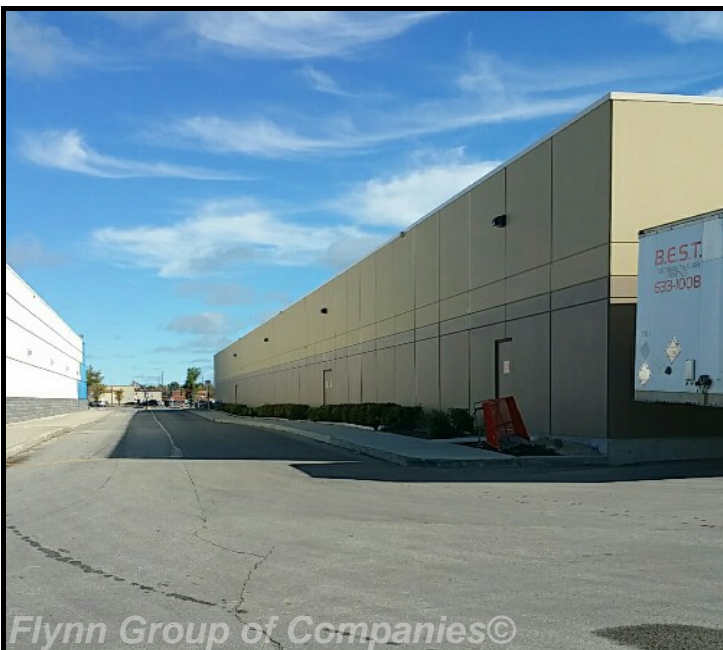
Overview: Exterior view of the south side of the building.

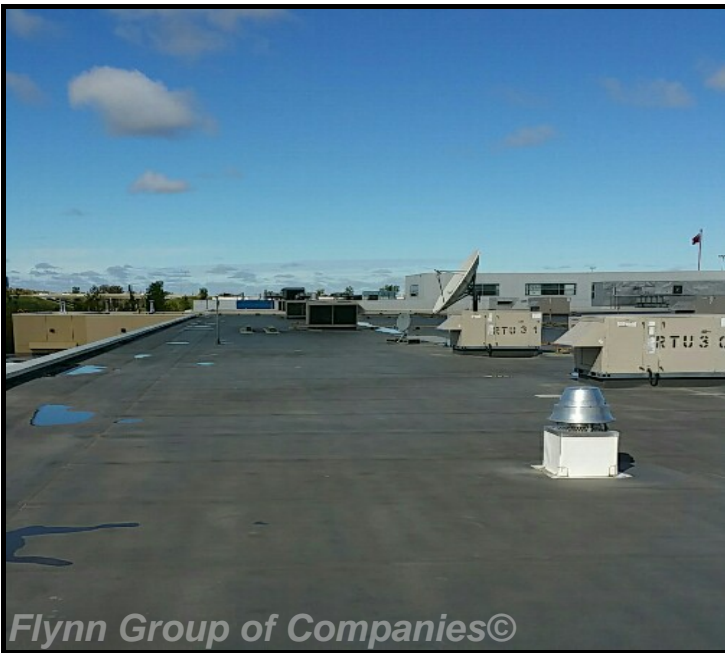
Section\_A: Overview of roof section A looking east.

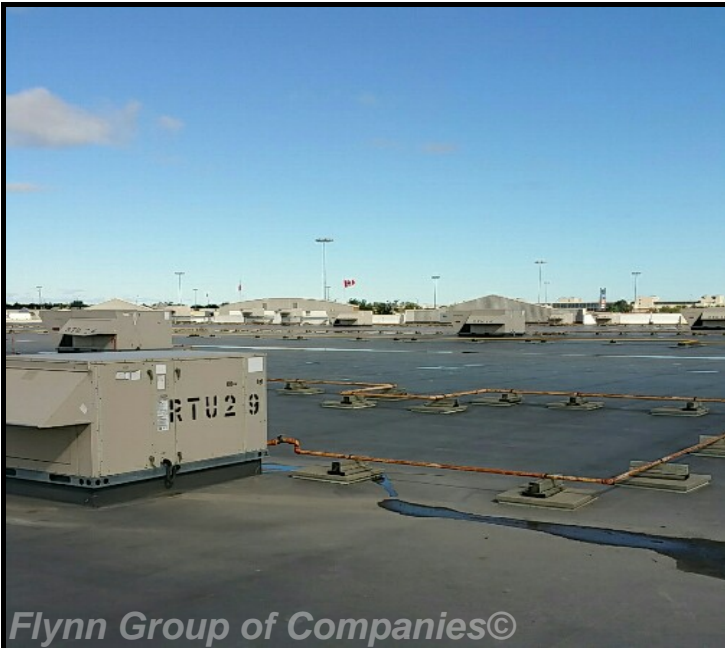
Section\_A: Overview of roof section A looking west.

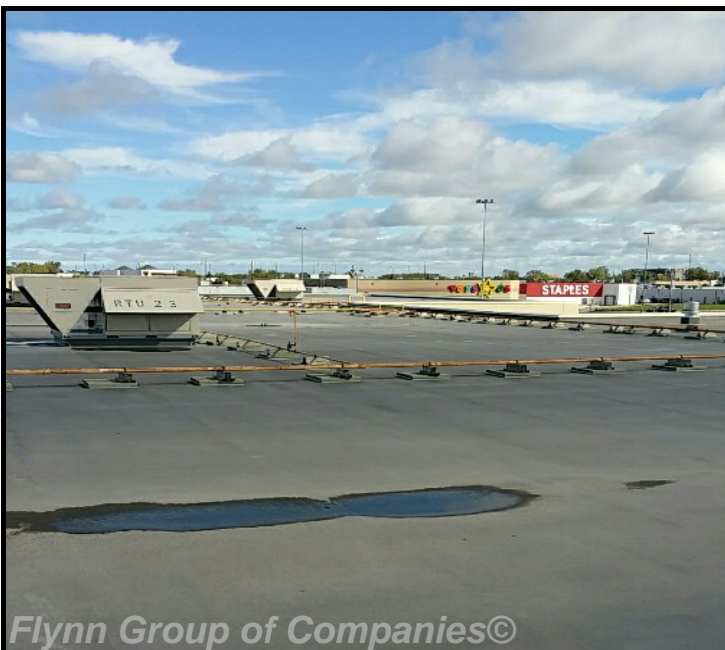
Section\_A: Overview of roof section A looking north.

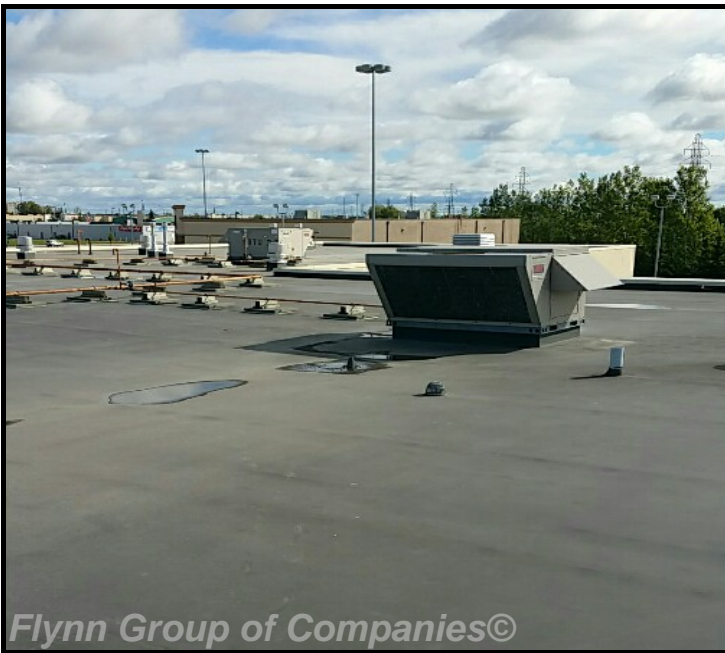
Section\_A: View looking north with one of the units in view.

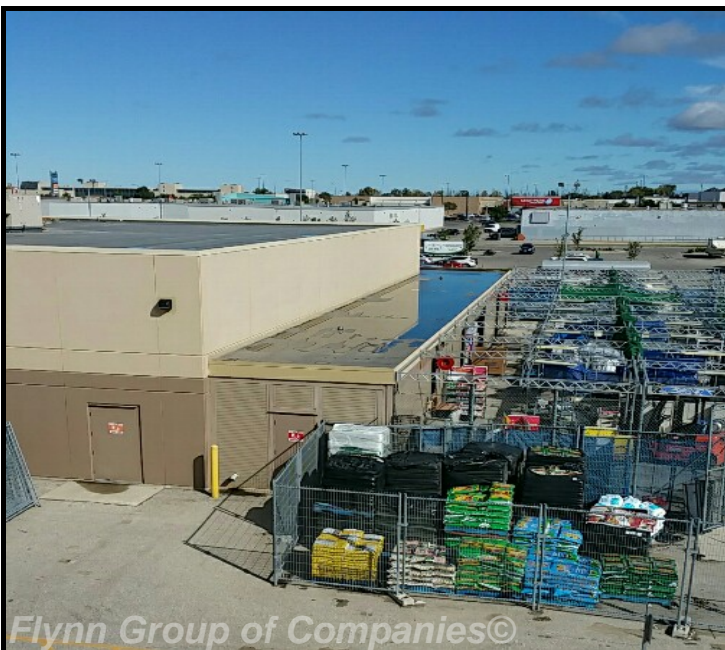
Section\_A:  
East canopy roof.

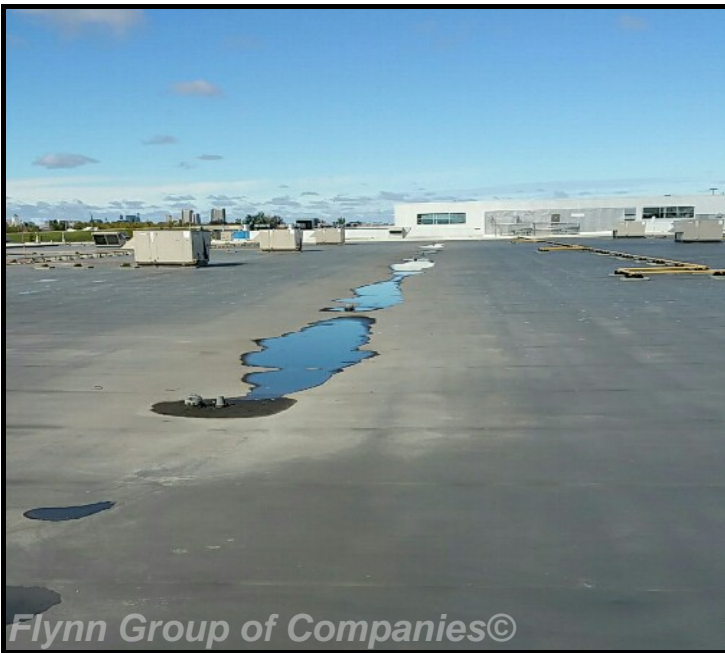
Section\_A: View of Section\_B  
west canopy.

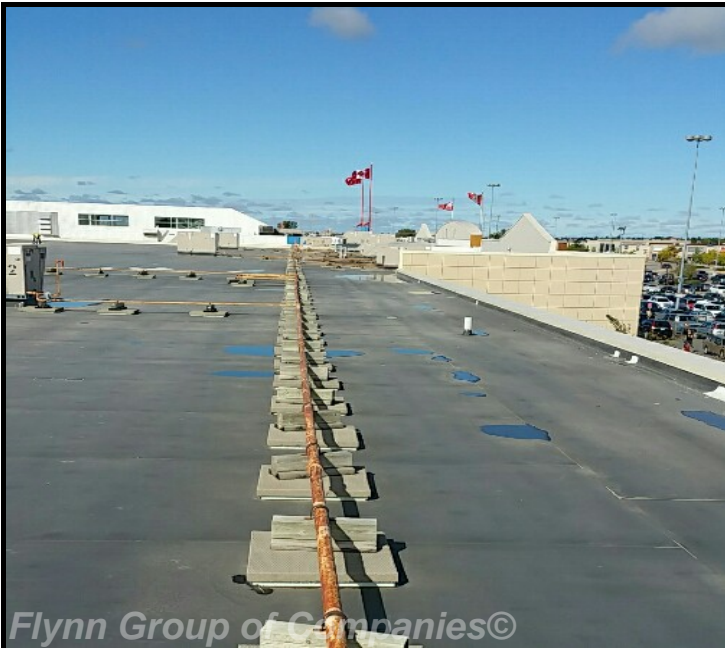
Section\_A:  
Water slopes to drains well.

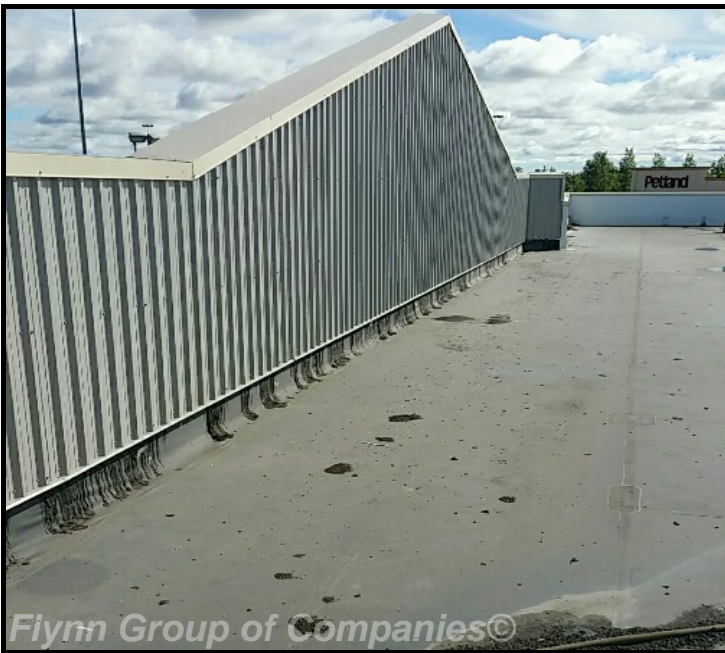
Section\_A: backside of parapet wall.

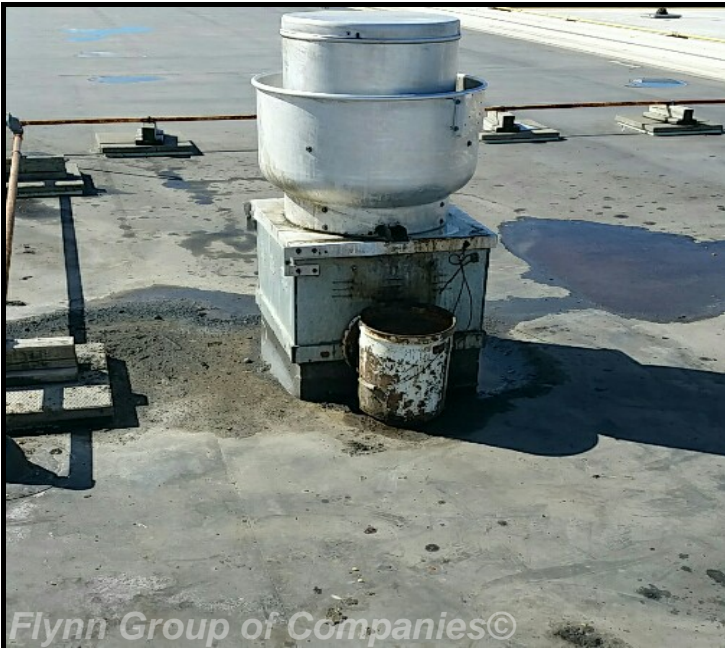
Section\_A:  
Grease vent needs new trap  
and cleaned around vent.

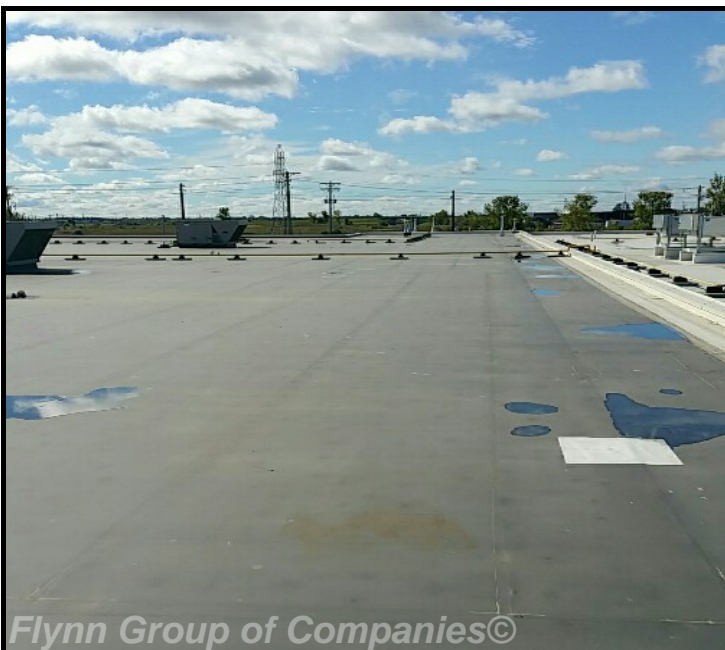
Section\_A: view looking west

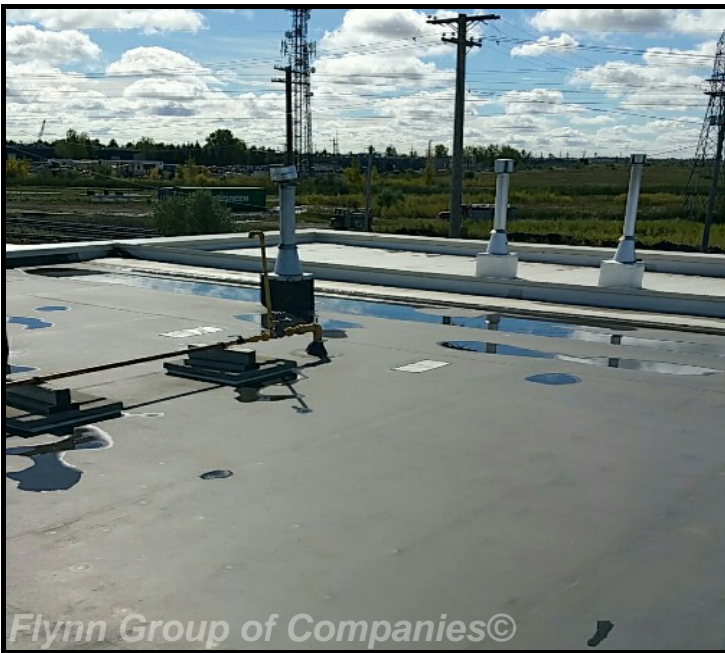
Section\_A: southeast corner of Section\_A

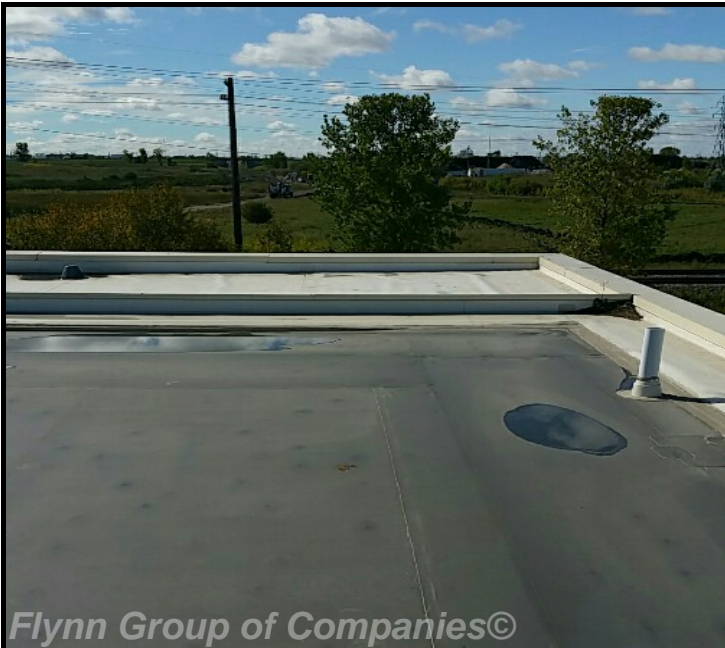
Section\_A: southwest corner of Section\_A

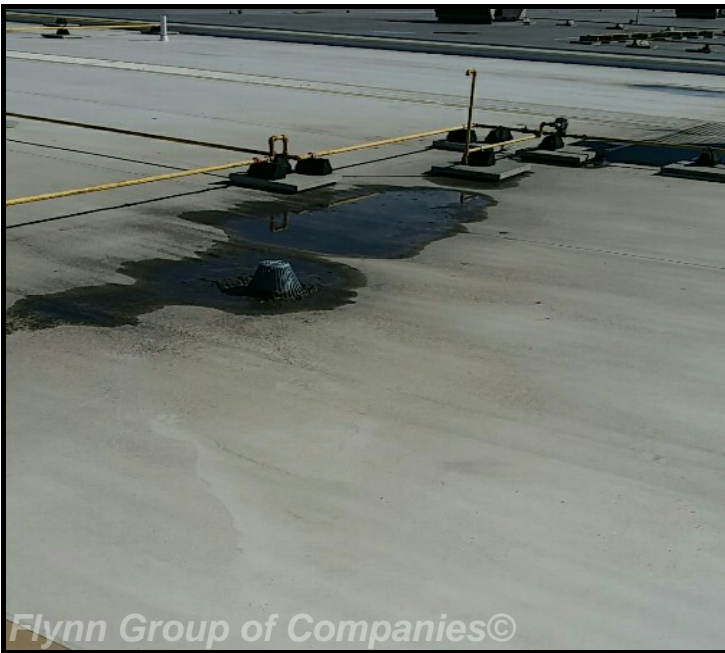
Section\_B: Drain in need of cleaning.

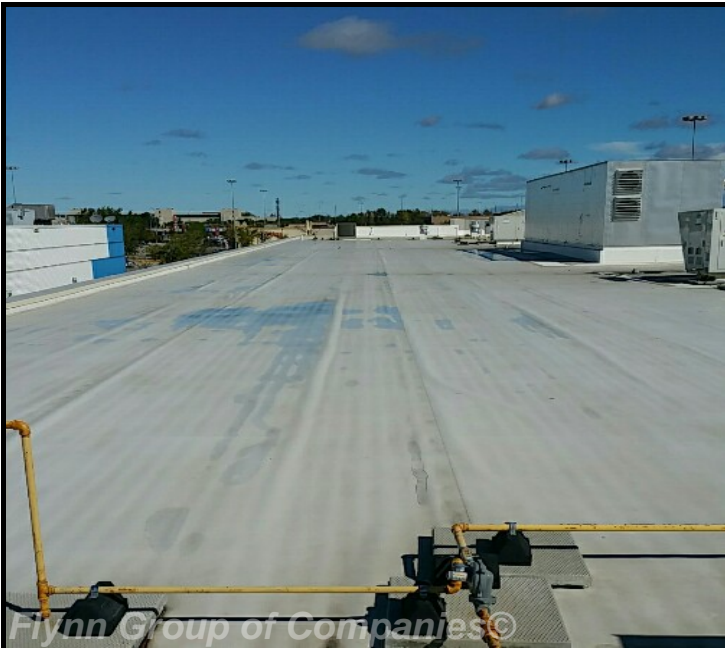
Section\_B: View east on section\_b.

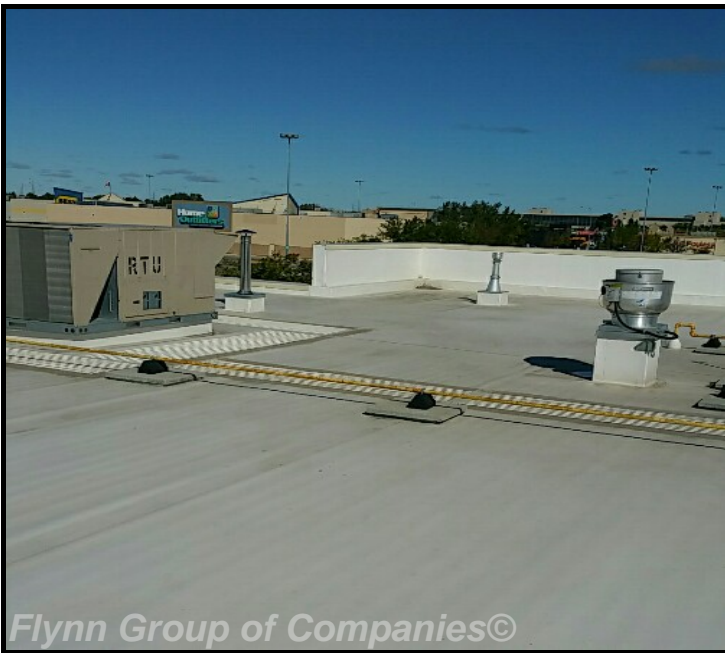
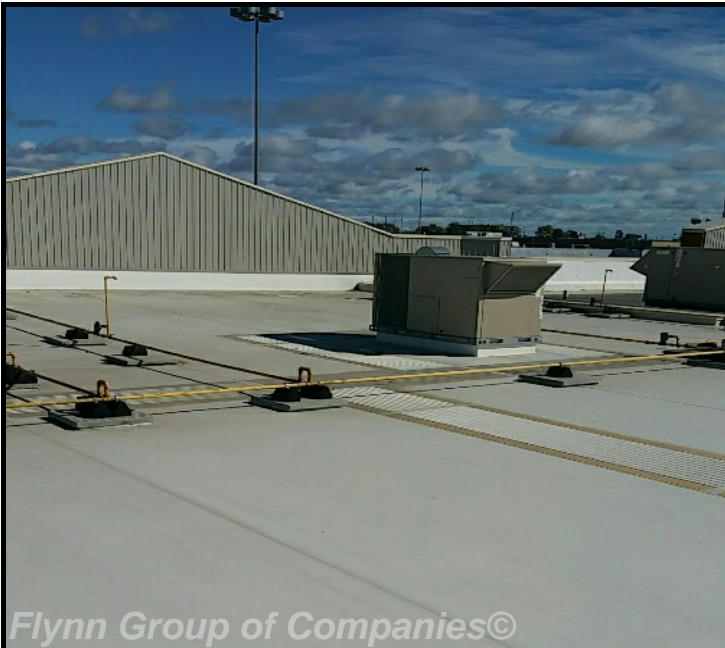
Section\_B: Parapet wall, grease vent and unit on section\_b.
